A-E SERVICES TO PERFORM A CATHODIC PROTECTION SURVEY OF
THE BULK FUEL TERMINALS AT N.S.C., PEARL HARBOR, HAWAII

VOLUME II

JUNE 1982

PACIFIC CORROSION RESEARCH, INC.
5481 B COMMERCIAL DRIVE
HUNTINGTON BEACH, CALIFORNIA 92649

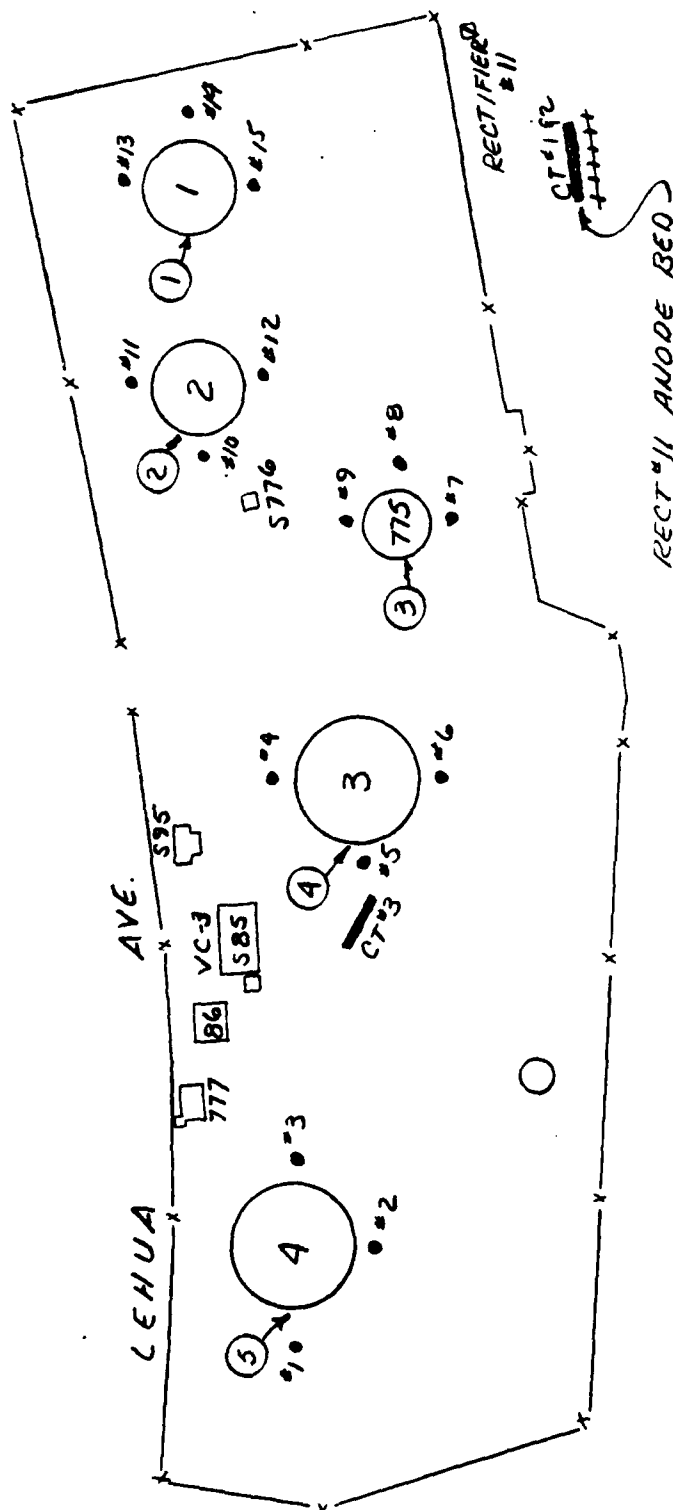
PACIFIC CORROSION RESEARCH CONSULTING CORROSION ENGINEERS HUNTINGTON BEACH, CALIFORNIA	
BULK FUEL TERMINALS NSC, PEARL HARBOR, HAWAII	
CORROSION SURVEY	
FIELD DATA	SECTION: C-1
DRAWN: R.E.F.	DATE: 2-15-82
APPROVED: <i>[Signature]</i>	NUMBER: 6505

- A. The soil environment of Section C-1 can be classified as an area of severe corrosion potential.
- B. The fuel tanks of Section C-1 were found to be electrically continuous with the POL lines of Sections A-1, A-2, A-4 and A-5.
- C. It was found that the external bottom surface areas of the fuel tanks were not receiving full cathodic protection during this survey.
- D. Approximately 74,900 sq. ft. of steel structures (external tank bottom surface areas) are to be considered for cathodic protection in Section C-1. Approximately 35 amperes D.C. will be required to provide a protective potential.

The low resistivity indicates a severe corrosion condition on underground metallic structures. Seventy-three percent of the measurements obtained were in the severe category and twenty-seven percent were in the medium or moderate category.

B. "As Found" Pipe-to-Soil Potentials: "As Found" pipe-to-soil potentials were obtained at four sides of each tank. The measurements obtained indicated that the external bottom surface areas of the tanks are not receiving full protection with a majority of the readings below -850 mv. Lower potentials were found at Tank #4 (S87) of the Pearl City Tank Farm. The results of these measurements are shown in Table No. XVI-B in the appendix of this report.

D. Leak History: We were advised by Base Fuel Personnel that Tank #4 had numerous leaks in the past and will be replaced with a new steel tank.

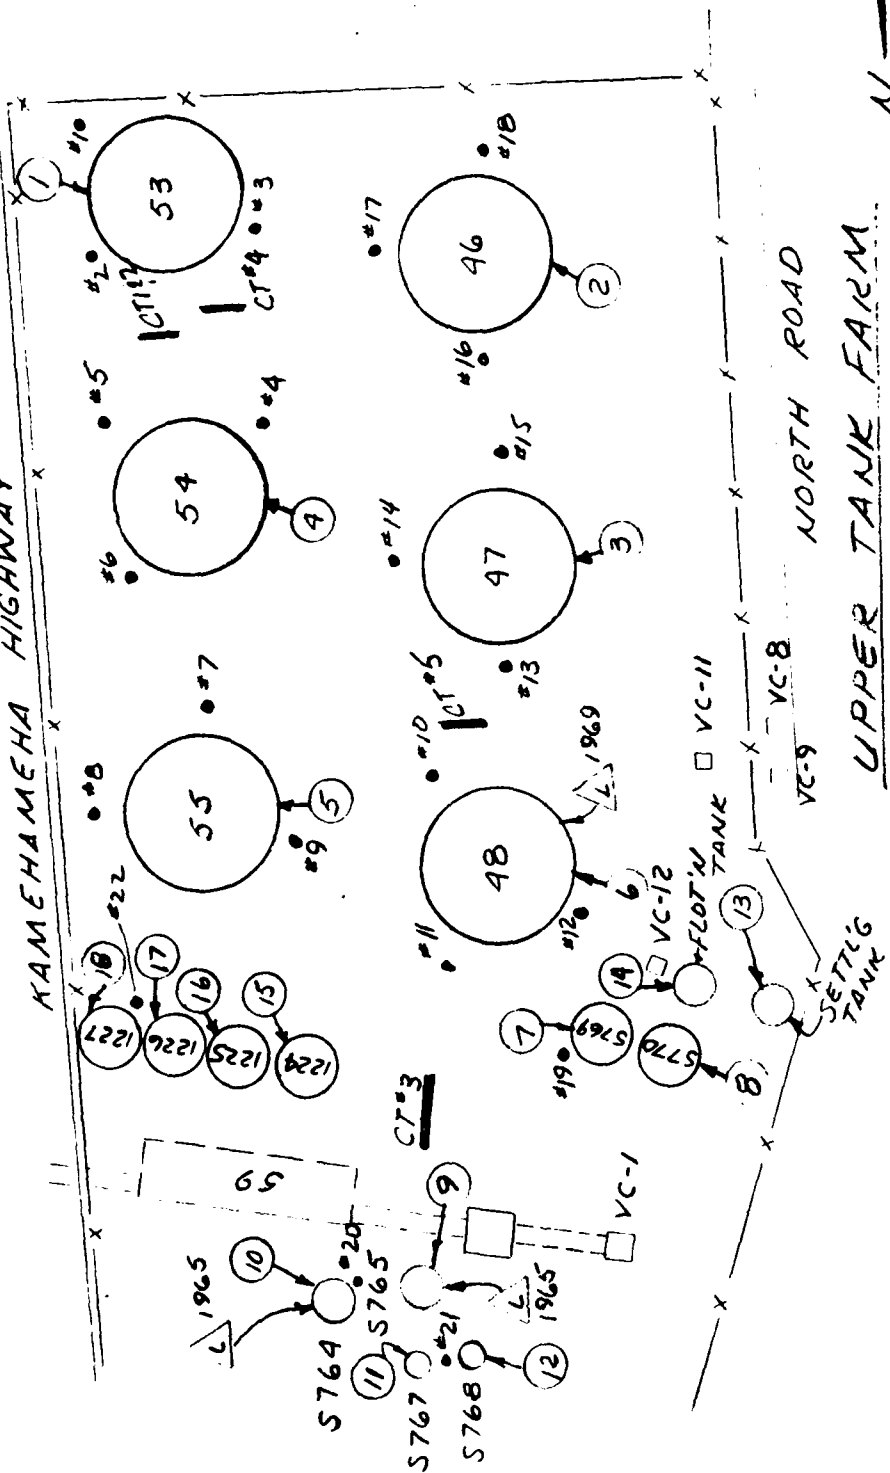
APPROVED: *A.T.S.* NUMBER: 6506

The low resistivity indicates a severe corrosion condition on underground metallic structures. One percent of the measurements obtained were in the severe category and ninety-two percent were in the medium or moderate category.

- B. "As Found" Structure-to-Soil Potentials: "As Found" potentials were obtained at various locations around each tank. The results of these measurements indicated that the tanks of Section C-2 are not at a protective potential level with a majority of the readings below -700 mv. The results of these measurements are shown in Table No. XVII-B.
- C. Current Tests: A total of five current tests were conducted at various locations in the Upper Tank Farm area. Structure-to-soil potentials were obtained at representative locations around the tanks with the test rectifier "off" and "on".
- (1) Current Test No. 1 - This current test was conducted in the area north of Tank #53 (S761). Ten steel rods were installed 40' north of Tank #53 as a test anode bed. The negative from a test rectifier was connected to the existing grounding rod of Tank #54. The cur-

- b. The fuel tanks of Section C-2 were found to be electrically continuous with the POL lines of Sections B-1 thru B-9.
- c. Tanks S761, S764 and S765 were found to be electrically discontinuous with the other tanks and piping systems of this section.

- d. All tanks in Section C-2 are not receiving adequate cathodic protection.
- e. It was found that the current demand for protection of the tanks of Section C-2 will be high. For protection of the four underground steel tanks (S1224 thru S1227) it will be necessary to install an impressed current system by installing anodes around these tanks.

D. Leak History: We were advised by the base fuel personnel that a leak on the internal bottom of Tank #48 was found and repaired in 1969. Lube tanks #1 and #2 have been abandoned

due to leaks. The POL lines to these two tanks were found to be disconnected at the time of this survey.

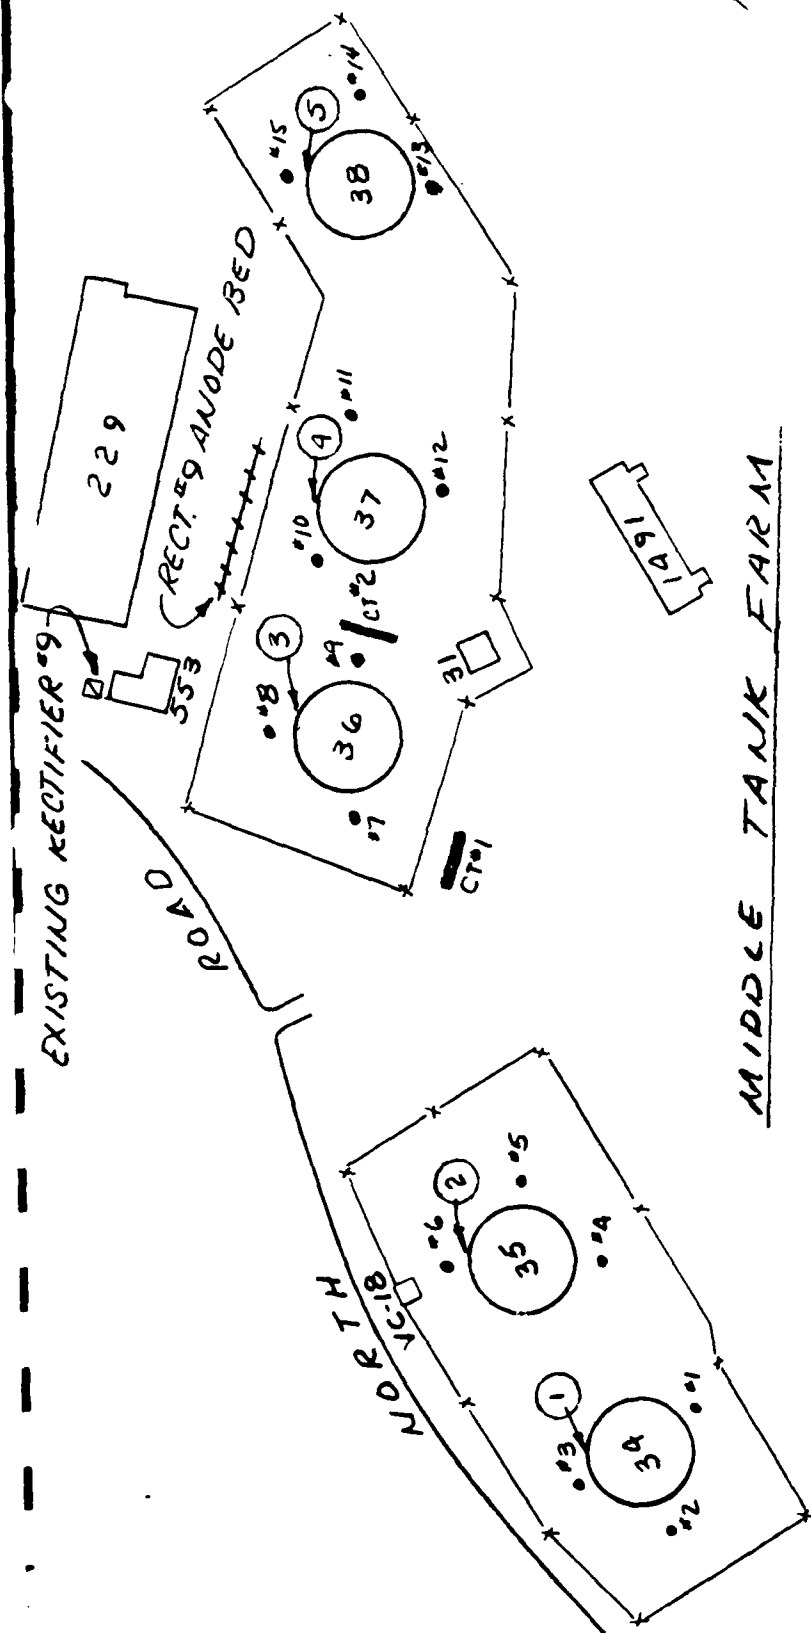
APPROVED: 4/78 NUMBER: 6507

The low resistivity indicates a severe corrosion condition on underground metallic structures. Two percent of the measurements obtained were in the severe category and ninety-eight percent were in the medium or moderate category.

B. "As Found" Tank-to-Soil Potentials: "As Found" tank-to-soil potentials were obtained at four sides of each tank. The results of these measurements indicated that the external bottom surface areas of the tanks in Section C-3 are not at a protective potential level. The results of these measurements are shown in Table No. XVIII-B.

D. Leak History: We were advised by the base fuel personnel that no leaks were found in the past.

- A. Soil resistivity measurements indicated that 98% of the readings are in the moderate category. The environment in Section C-3 can be classified as an area of moderate corrosion potential.

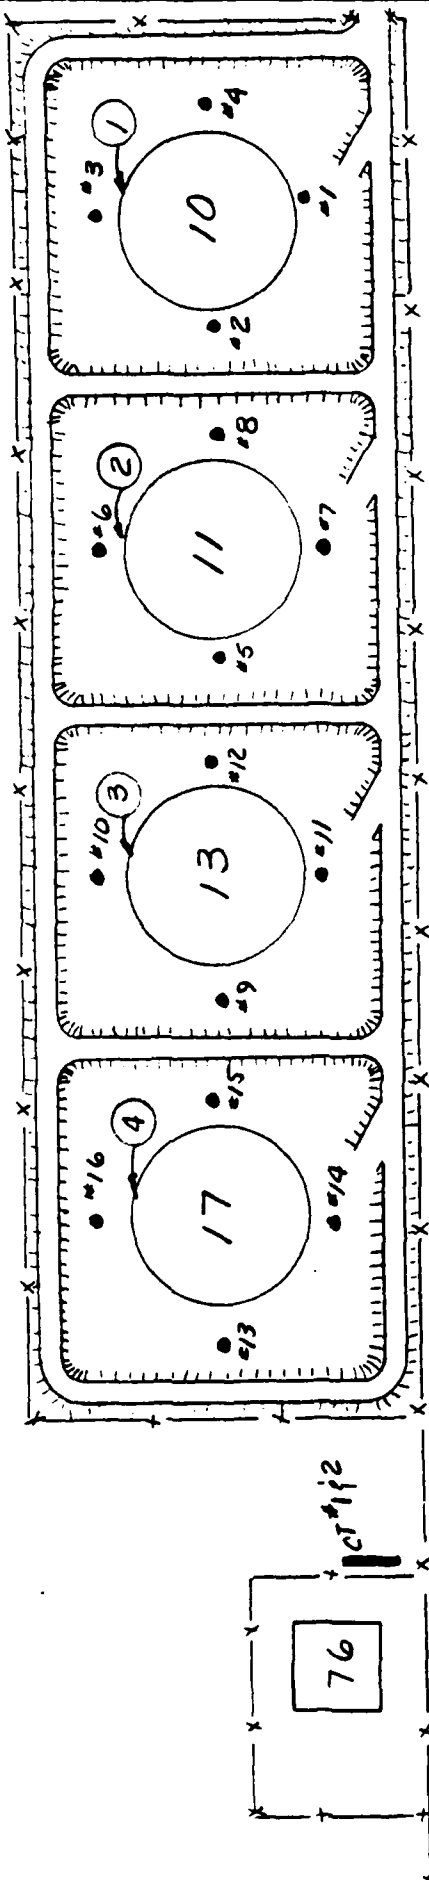
APPROVED: *[Signature]* NUMBER: 6508

- A. The soil environment in Section C-4 can be classified as an area of moderate corrosion potential.
- B. The external bottom surface areas of tanks and the POL lines in the Lower Tank Farm are not at a protective potential level, with all potentials below -500 mv.

- (1) The 18" cast iron POL lines from Pumphouse 76 to the Navy Shipyard.
 - (2) The cast iron fire mains around the tanks.
- E. The magnesium anodes installed around the tanks were found to have deteriorated and have exceeded their useful service life.

The tanks were originally designed to be protected by a sacrificial anode type cathodic protection system. The magnesium anodes installed around the tanks were found to have deteriorated and were beyond their useful service.
